# CEMWHR-2022

Case Studies for Challenges faced and Benefit Gained

A Presentation by  
Bharathi Cement Corporation Pvt Ltd  
Kadapa Dist., Andrapradesh

WHRS Unit Capacity : 9.5 MW  
Commissioned : Sep 2019

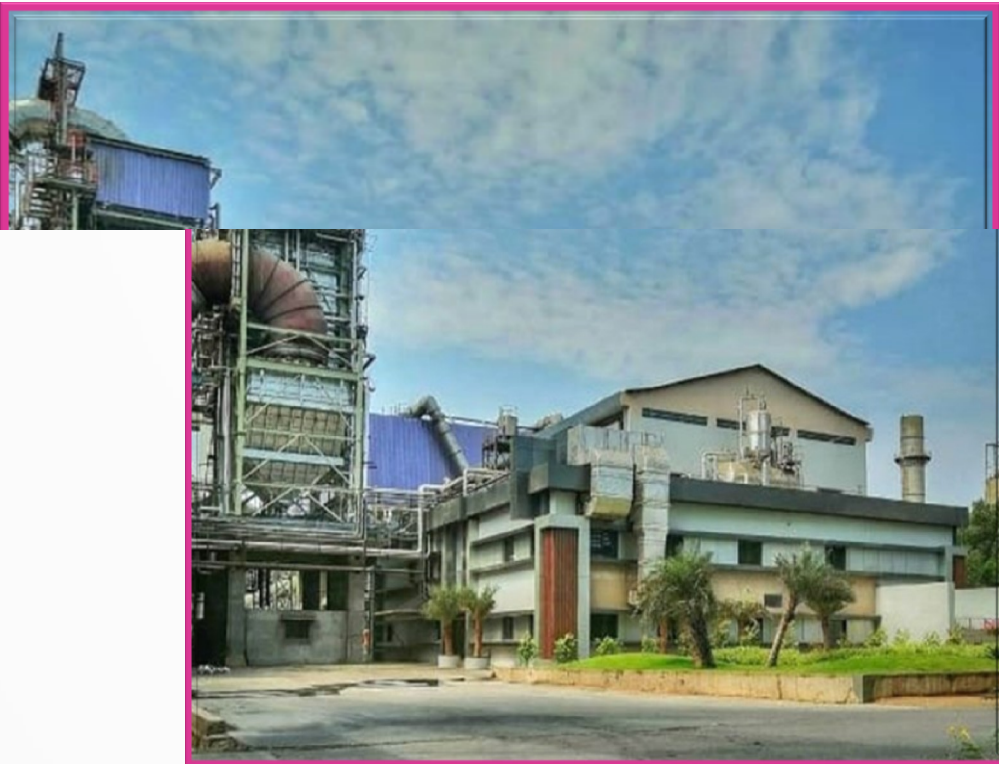
**Kiln Capacity : 6200 TPD**

AQC boiler-1 :  
HP steam-23.7 TPH & LP Steam-4.5TPH

Preheater boiler-1:  
HP steam-14.5TPH & LP Steam-11.5TPH

Make: ISGEC , Noida

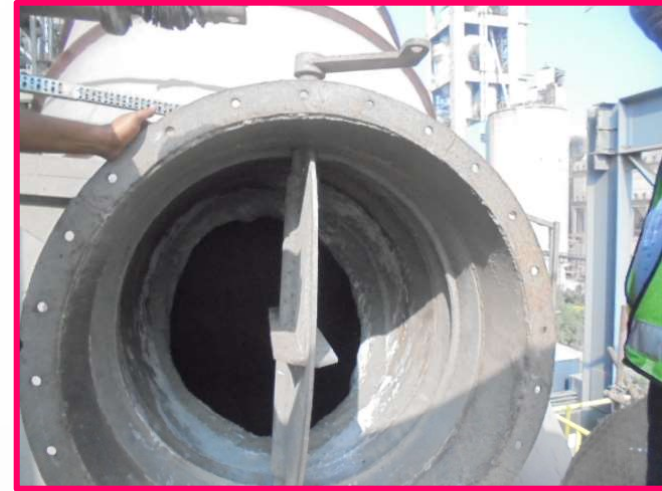
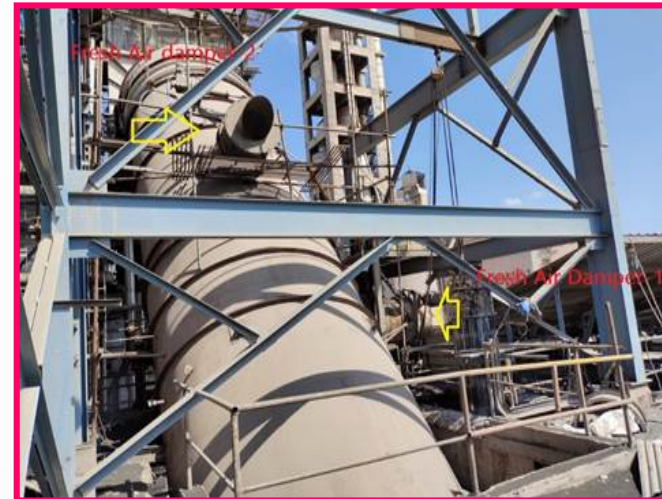
# Case Studies-1

## Additional Fresh Damper Requirement : AQC Boiler

Tripping's of WHRS unit on High steam temperature during kiln abnormal condition

Installed additional Fresh air damper to inlet flue gas duct of Boiler. Flue gas temperature controlling taken through end tap damper auto operation and auto water spray system in cooler.

- ✓ Eliminâtes high temp.trippings
- ✓ Increased Plant Availability
- ✓ reduced DM water consumption
- ✓ Reduced Genearation loss on trippings

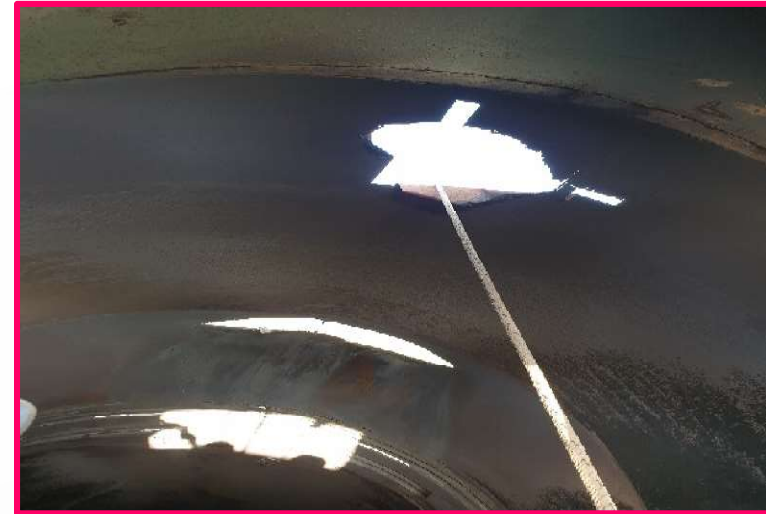
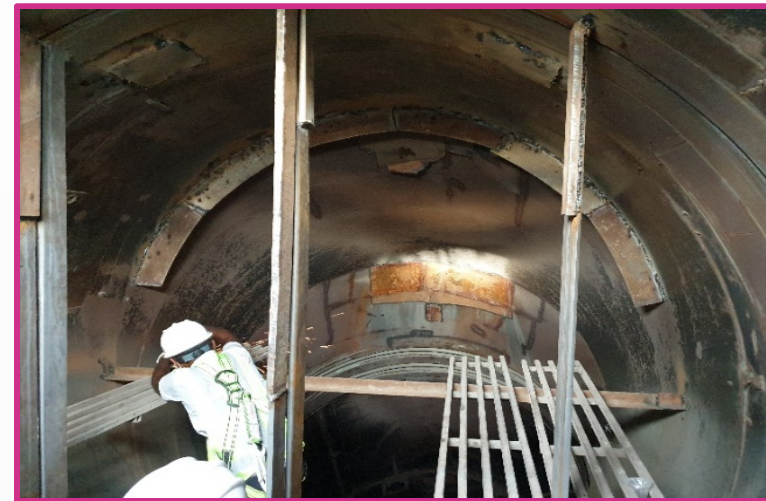
## Case Studies-3

# Flue Gas Duct Erosion : AQC Boiler

Flue gas duct erosion in AQC Boiler and overloading of Cooler ESP Fan

180 Deg Baffle arrangements provided for the bend and expansion bellow for diverting the flow where the high erosions are taken place

- ✓ Eliminated duct erosion
- ✓ Reduced Cooler ESP fan Power consumption
- ✓ Clean Environmental atmosphere

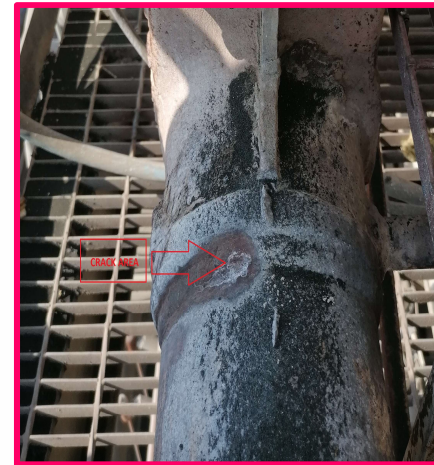
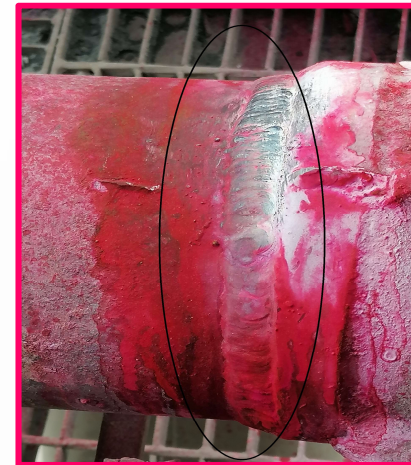
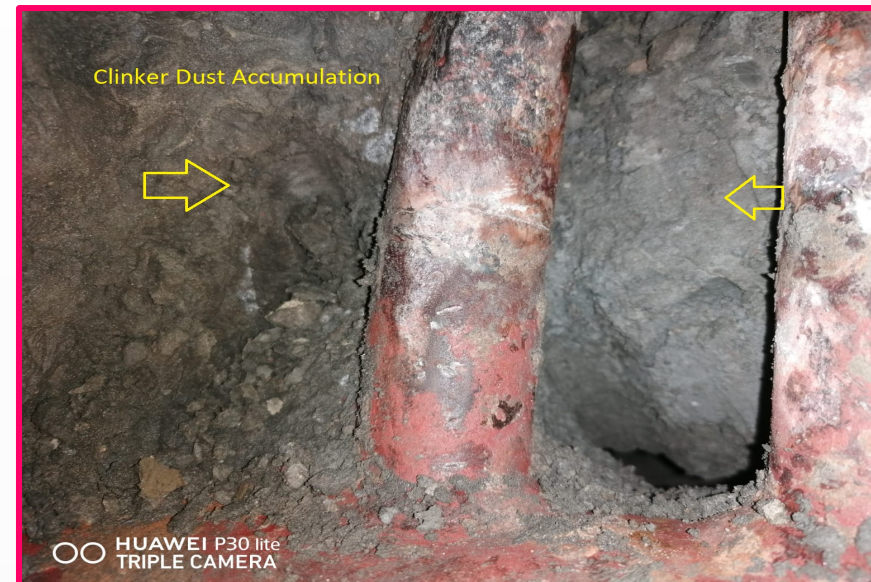
# Case Studies-4

## LP Steam Lines Cracks : AQC Boiler

Repeated cracks occurred in LP Main steam line

- All Expansion supports made free to expand the MS line
- PMI test for Main steam line carried out
- Header Casing opened and checked for clinker dust accumulation.
- Thick Packing of ceramic wool provided for header casing
- Baffle arrangement given for coil assy bottom

- ✓ Cracks on MS line sort-out
- ✓ Free Expansion of MS line
- ✓ Repairing & Maintenance cost reduced

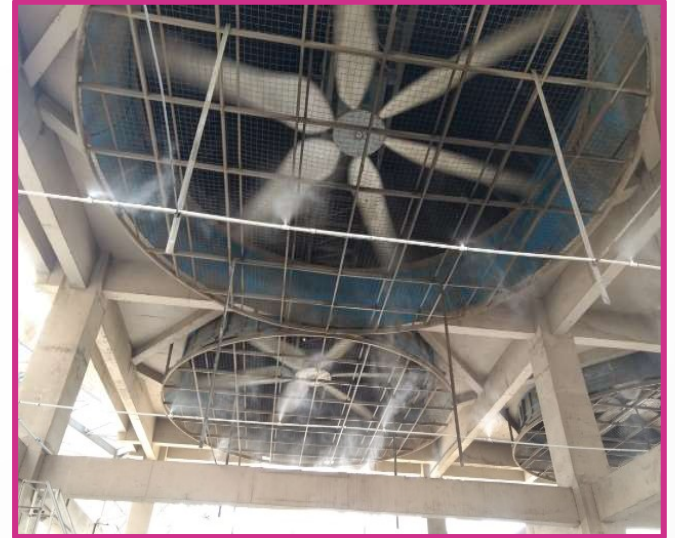
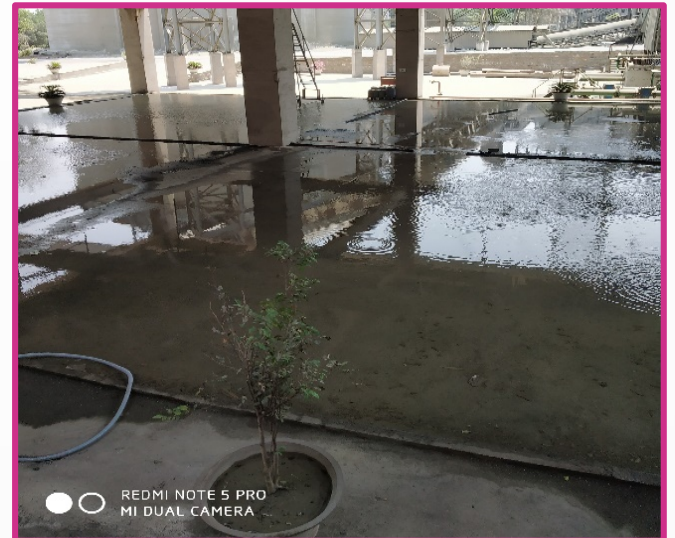
# Case Studies-5

## Vacuum Stability in Dusty Atmosphere: ACC

Poor Vacuum stability during peak summer

1. Installed water mist fog spray system
2. Cleaning of Bundles with hardness nil water on 15 days of frequency
3. Water pond made at bottom of ACC fan building concrete face for dust collection

- ✓ Dustless free air intake to ACC fan
- ✓ Vacuum stability increased
- ✓ Maximise the generation during peak summer hrs.

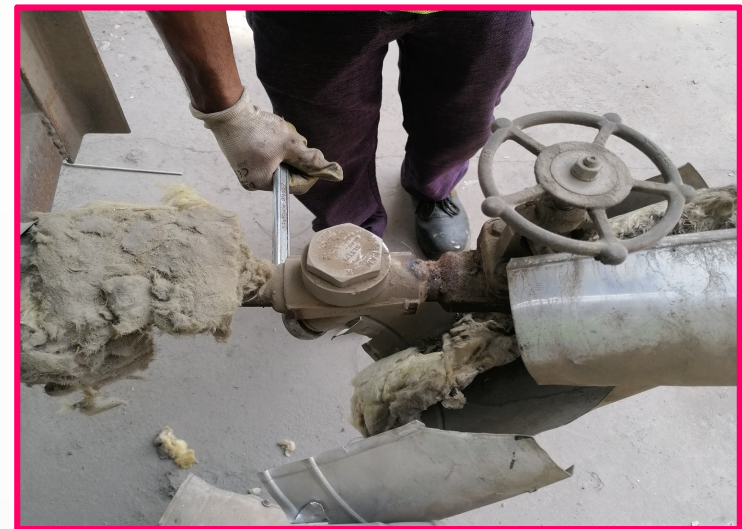
# Case Studies-6

## Importance of Steam trap Management System

Low Temperature Maintained in LP Main Steam line to Turbine

We are Maintaining steam trap management system on monthly basis through right time maintenance schedule

- ✓ Reduced liquid droplet erosion in tubes bends
- ✓ Increased LP MS temperature to Turbine
- ✓ Reduced steam losses
